Manhole Inspection Summary

Manhole # S51C__039MH

Insp Date: **5/5/08 9:41 AM**

Location Address: **37 n decker**

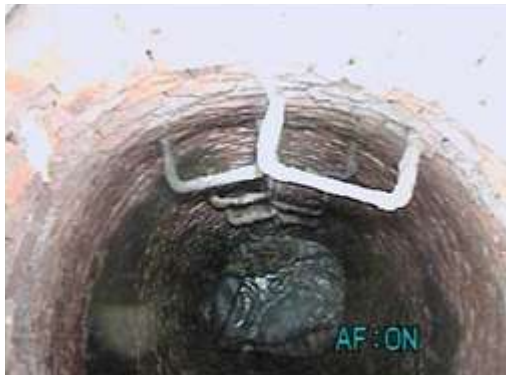
Defect 2

Count: **11** Missing: **3** ☒ **Corroded**

steps

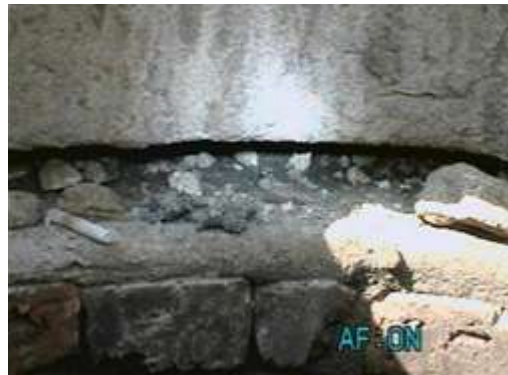
Defect 1

Offset: **4** (in.)

Condition: ☐ Sound ☐ Cracked ☐ Root Intrusion ☐ Loose Brick ☒ **Deteriorated**

corbel deteriorated & frame offset

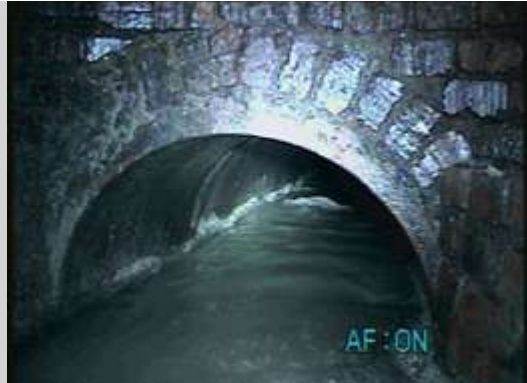
12 O'Clock Outflow

27 in. Circular Gravity Sewer
Pipe Out @ 12 OClock

Pipe Material: Clay ☐ Pipe Lined

Invert Depth: 21.06 (ft.) Flow Characteristics: Fast

Infiltration: None Pipe Seal Cond: Unknown

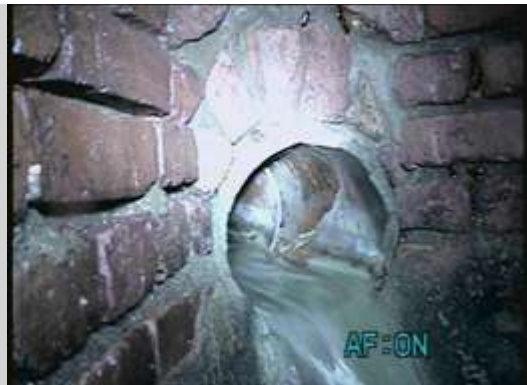
3 O'Clock Inflow

8 in. Circular Gravity Sewer
Pipe In @ 3 OClock

Drop In @ 3 OClock

Drop: Inside Direct

Drop Condition: Open

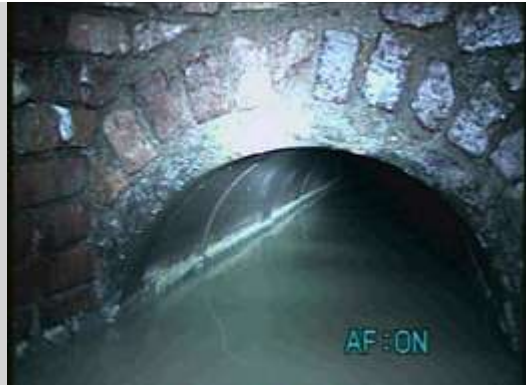
7 O'Clock Inflow

27 in. Circular Gravity Sewer

Pipe In @ 7 O'Clock

Pipe Material: **Concrete** ☐ Pipe Lined

Infiltration: **None** Pipe Seal Cond: **Unknown**
